**PROJECT:** COOK LANDING SITE:- PROPOSED CLEARWAY & 'SENSE OF PLACE' ASSESSMENT

**CLIENT:** NZ HISTORIC PLACES TRUST & DEPARTMENT OF CONSERVATION

**TABLE 1 SITE VISIBILITY ANALYSIS – FORMER AND CURRENT**

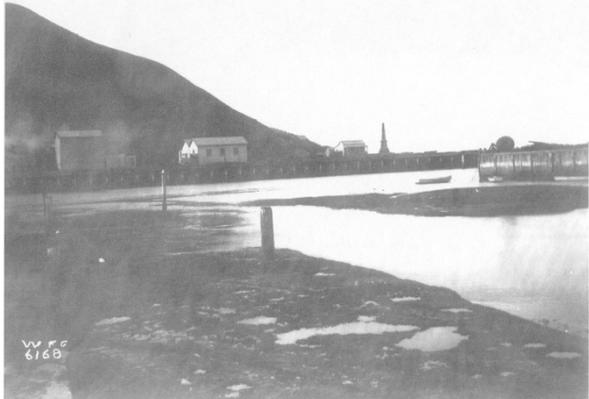
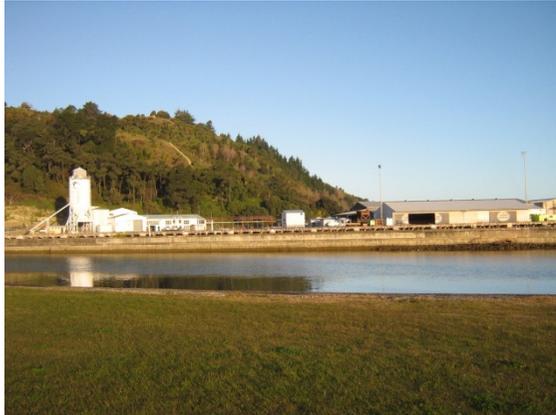
NUMBER	PHOTO LOCATION	A) EARLIER PERIOD	B) CURRENT 2000s
1	From the banks of the Waikanae Creek/Turanganui River

View characteristics	Cook Monument form prominent in the view. Panoramic, unencumbered view to Monument and its surroundings. 1909	Tip of Cook Monument visible. Cook Monument has negligible value from this location. 2008
2	View towards Cook Monument from sea

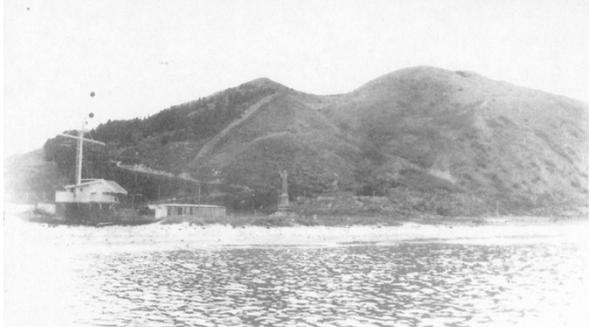
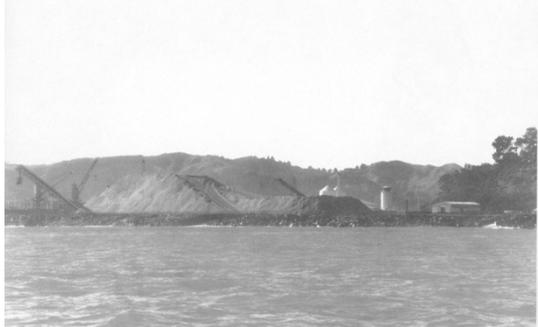
View characteristics	Cook Monument form prominent. Panoramic view type; unencumbered view to monument. (undated)	Tip of Cook Monument visible. Monument has negligible value from this location. Scale of monument dwarfed by port buildings and works. Cone of Vision closed. 2002

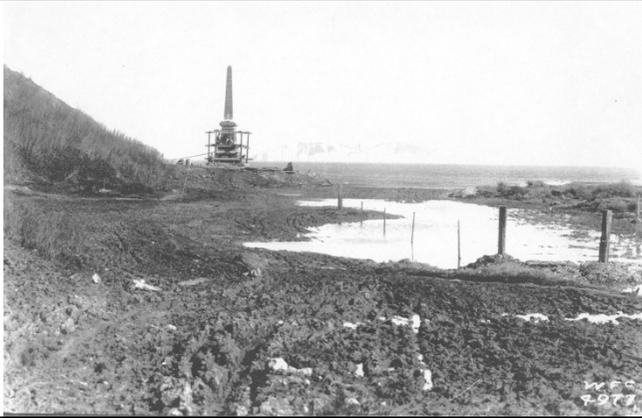
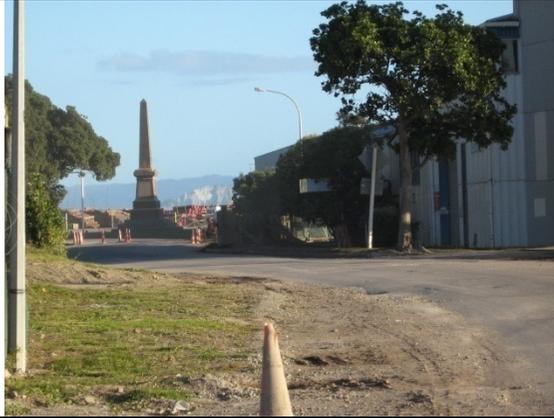
NUMBER	PHOTO LOCATION	A) EARLIER PERIOD	B) CURRENT 2000s
3	View towards Monument from (approximate) location of the Esplanade

View characteristics	Monument form prominent. Panoramic view; unencumbered view to monument. (August 1906 WF Crawford Collection)	Monument form prominent. Enclosed view possible with buildings blocking open views to young Nicks Head. Cone of Vision closed, but views to Young Nick's head possible over logs. 2008
4	View towards the Monument from lower Kaiti Hill

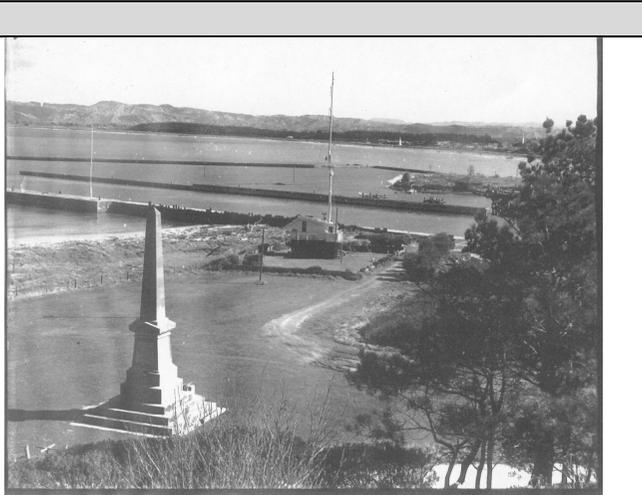
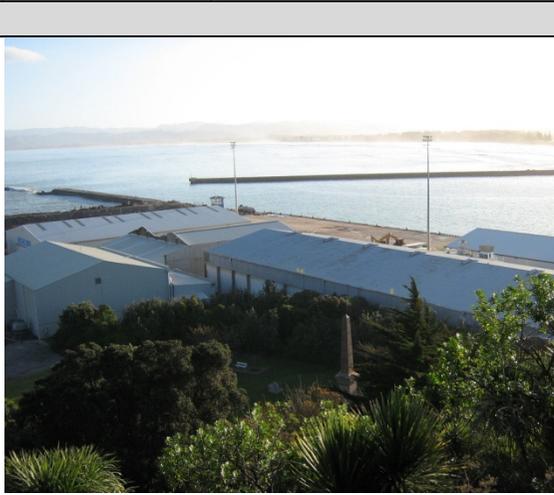
View characteristics	Panoramic view with clear linkages between Kaiti Hill, the Monument and the foreshore beyond. c1950s.	Enclosed view from Te Kuri a Paoa Lookout with separation of the Monument within the Heritage Reserve from the foreshore beyond. 2008.

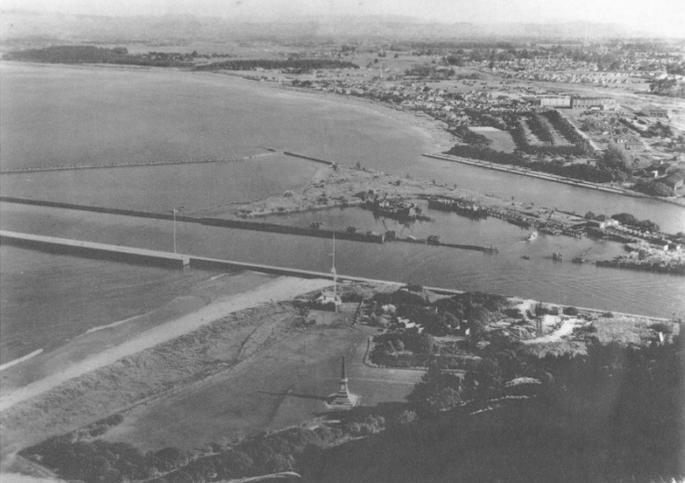
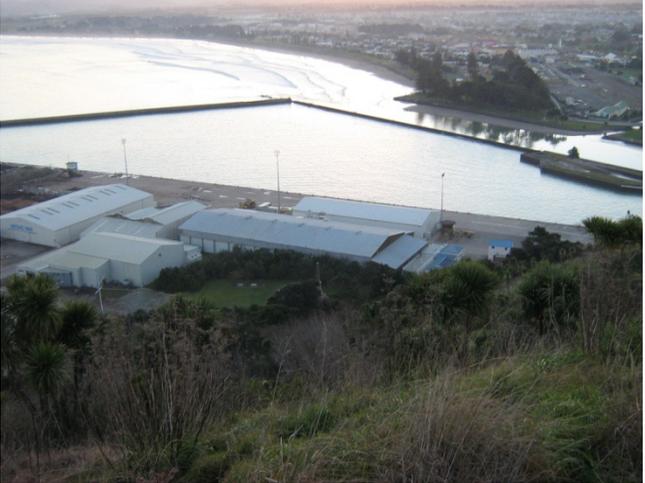
NUMBER	PHOTO LOCATION	A) EARLIER PERIOD	B) CURRENT 2000s
5	View towards the Monument from upper Kaiti Hill (1952)

View characteristics	Panoramic view with clear linkages between Kaiti Hill, the Monument and the foreshore beyond. 1952. [Alexander Turnbull Library].	Enclosed view from Cooks Plaza with separation of the Monument within the Heritage Reserve from the foreshore beyond. 2008
